Fire Research Report: The British Oxygen Company Limited,
150 Polmadie Road, Glasgow, G5

Date: Monday, 7th February, 1977
Time and method of call: 1035. Exchange telephone
Address: 150 Polmadie Road, Glasgow, G5

- (a) A 15 ton capacity Liquefied Petroleum Gas articulated road tanker, Registration number:- WNN 406H.
- (b) Liquefied Petroleum Gas bulk storage terminal consisting of 4 x 100 tons capacity cylindrical welded steel tanks with hemi-spherical ends, measuring 76 feet in length by 12 feet in diameter.

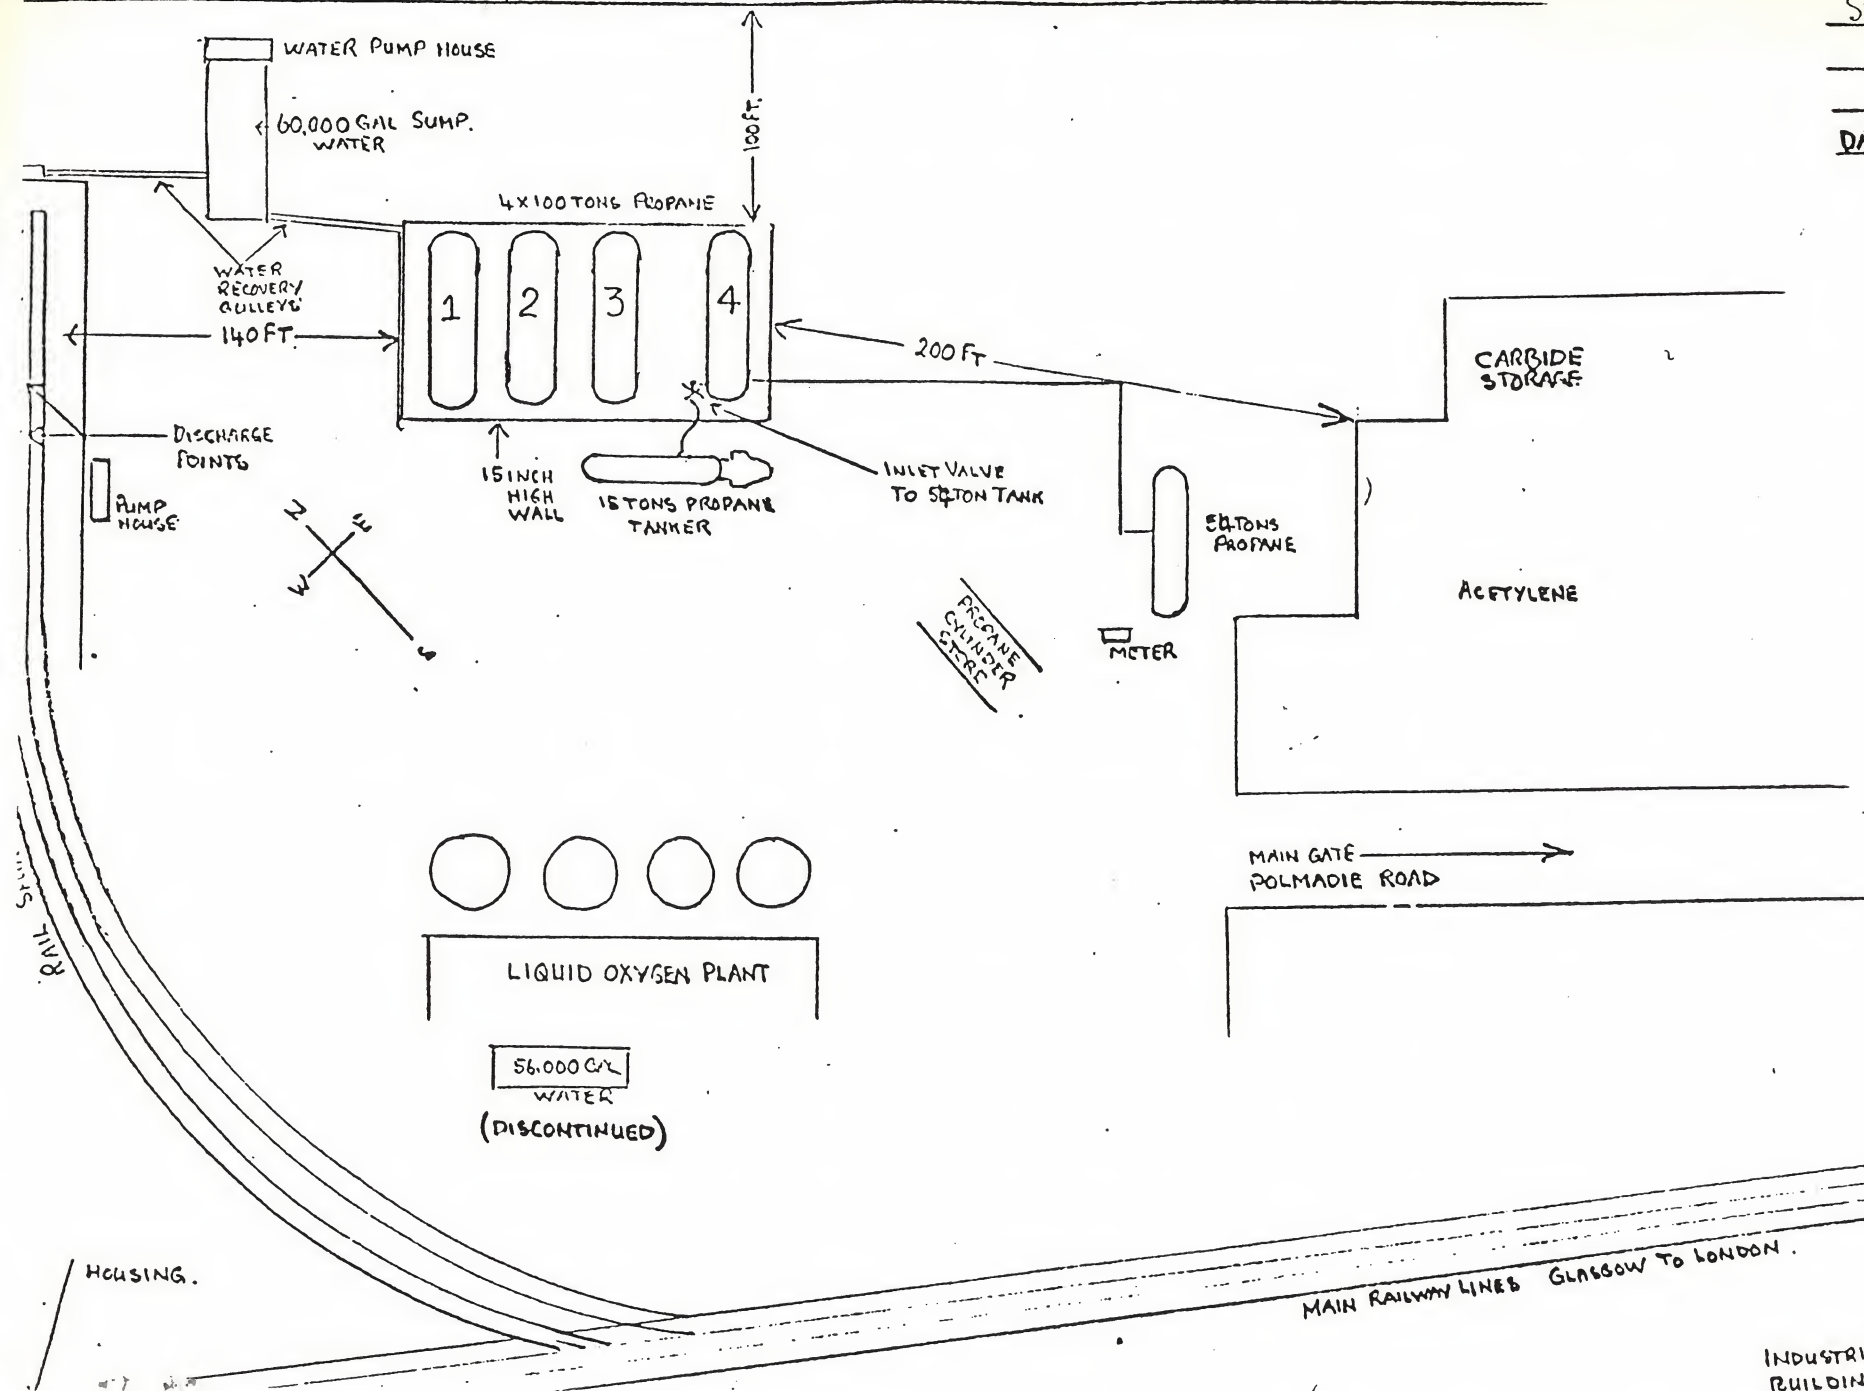
The inlet leading to the remotely sited 54 ton capacity storage tank is located almost immediately below No. 4 storage tank, the tanks being numbered from left to right. (See attached sketch).

The system failed at one vital point. The 'V' threaded blank cap of the three inch water pipe located below No.4 storage tank, immediately above the inlet valve to the 54 ton storage tank had either been left off or was so loosely connected that the force of water along the pipe dislodged it. The impinging jets served by this pipe therefore failed to function properly the water flowing freely from the end of the three inch pipe.

The gas flame from the tanker, partially impeded by the fifteen inch dwarf wall around the installation, enveloped the traction unit, the remainder of the flame impinging on to the lower end of No.4 storage tank and fifty feet along the lower left bottom of the tank. It also enveloped ancillary pipework and valves between Numbers 3 and 4 storage tanks.

With regard to the incident outlined in this report, it is felt that a serious situation developed due to the close proximity of the road tanker to the ends of the four storage tanks.

The tanker was parked about 15 feet from the ends of the storage tanks with outlets from the tanker facing the ends of the storage tanks. Had the road tanker off-loading point been remote from any storage tanks or had the road tanker been parked in such a manner that the delivery valves were facing away from the storage tanks, then the incident would most probably have been confined to a fire involving the road tanker and its contents only.
